AERIAL PHOTOGRAPHIC ANALYSIS OF LACLEDE GAS

St. Louis, Missouri

L. A. Lefkowitz Environmental Programs Lockheed Engineering and Sciences Company Las Vegas, Nevada 89193-3478

ENVIRONMENTAL MONITORING SYSTEMS LABORATORY OFFICE OF RESEARCH AND DEVELOPMENT U.S. ENVIRONMENTAL PROTECTION AGENCY LAS VEGAS, NEVADA 89193-3478

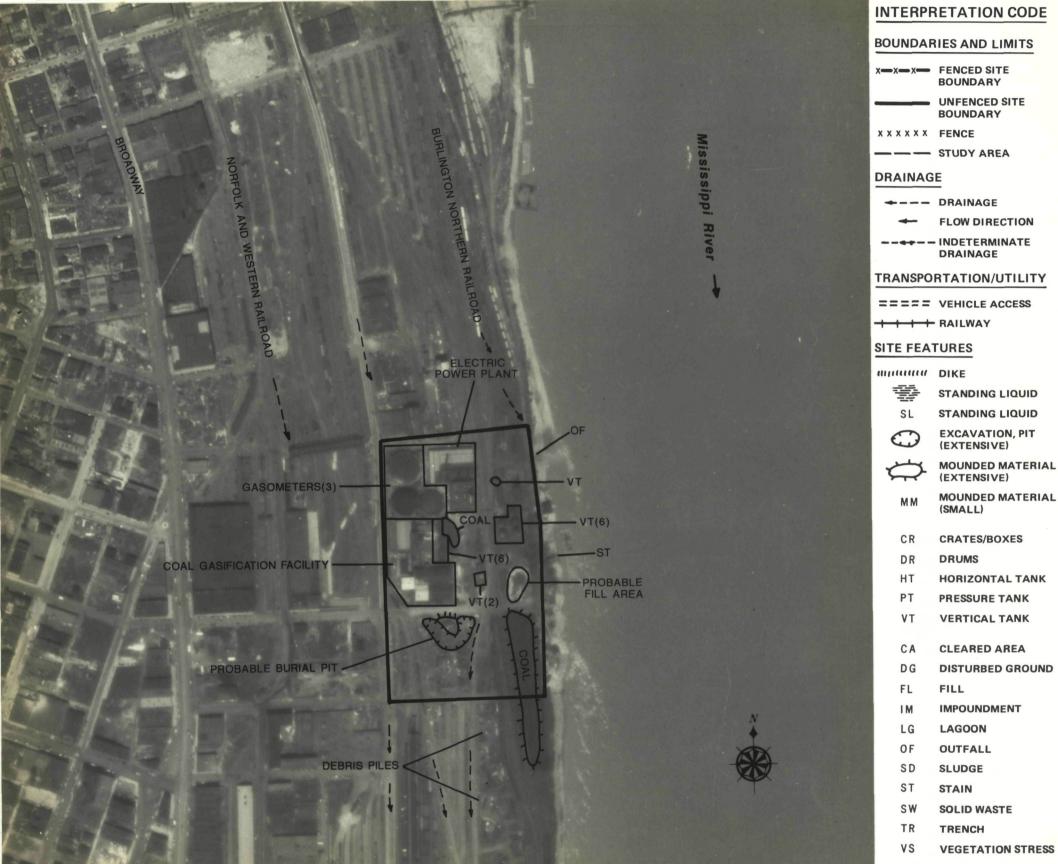
JULY 17, 1941 (FIGURE 3)

The 1941 photography is the earliest year of photographic coverage acquired. The photography shows the topography at the site as generally flat, situated on top of a high banked area adjoining the Mississippi River. There were no drainages evident on or around the site, except for the Mississippi River which lies to the east.

Two principal features of the analysis, an electric power plant and coal gasification facility, are located in the northwest portion of the site. A conduit discharging liquid (OF) into the river, is probably associated with the electric power plant. The three large gasometers observed to the immediate north of the coal gasification plant are components of the facility. The three gasometers observed, have attained different degrees of height. The height of the individual gasometers are proportional to their gaseous content.

An excavation in the southern portion of the site appears to be a burial pit containing scattered debris. A linear streak extending from the upper to lower portions of the river bank is dark-toned and probably a liquid stain. Above the stain is a fill of unidentified material.

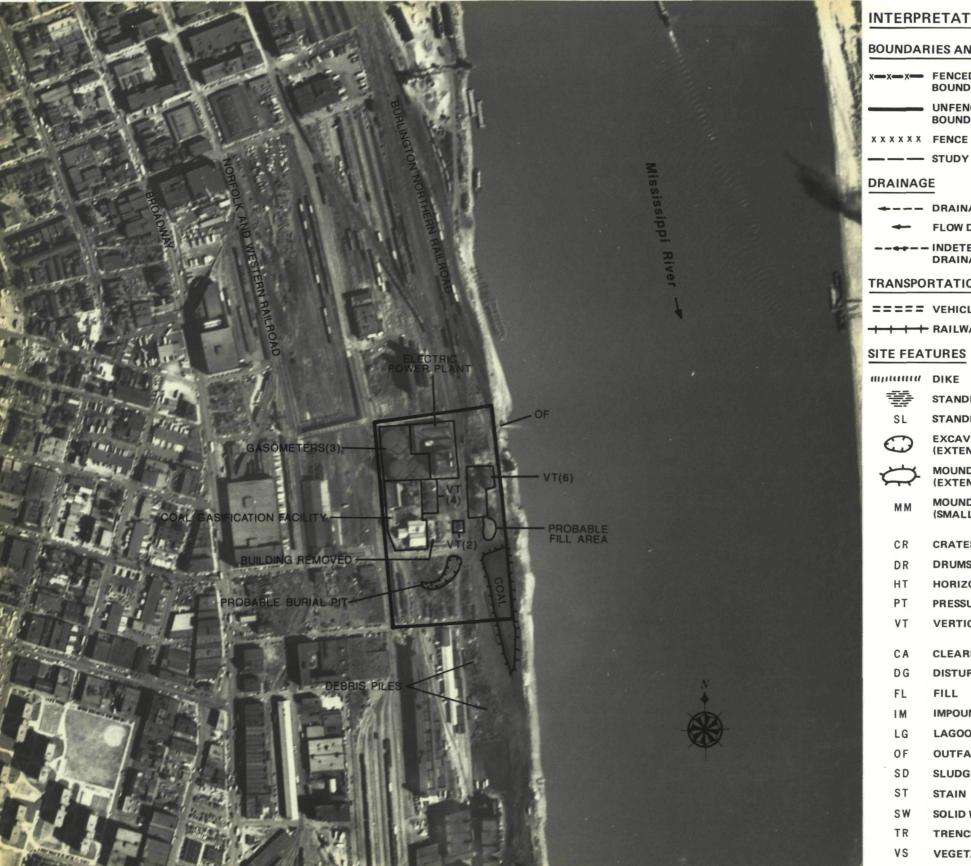
SEPTEMBER 8, 1953 (FIGURE 4)

The 1953 photography shows the partial dismantling of the coal gasification facility. A building in the southeast portion of the facility and two vertical tanks adjacent to the building have been removed.

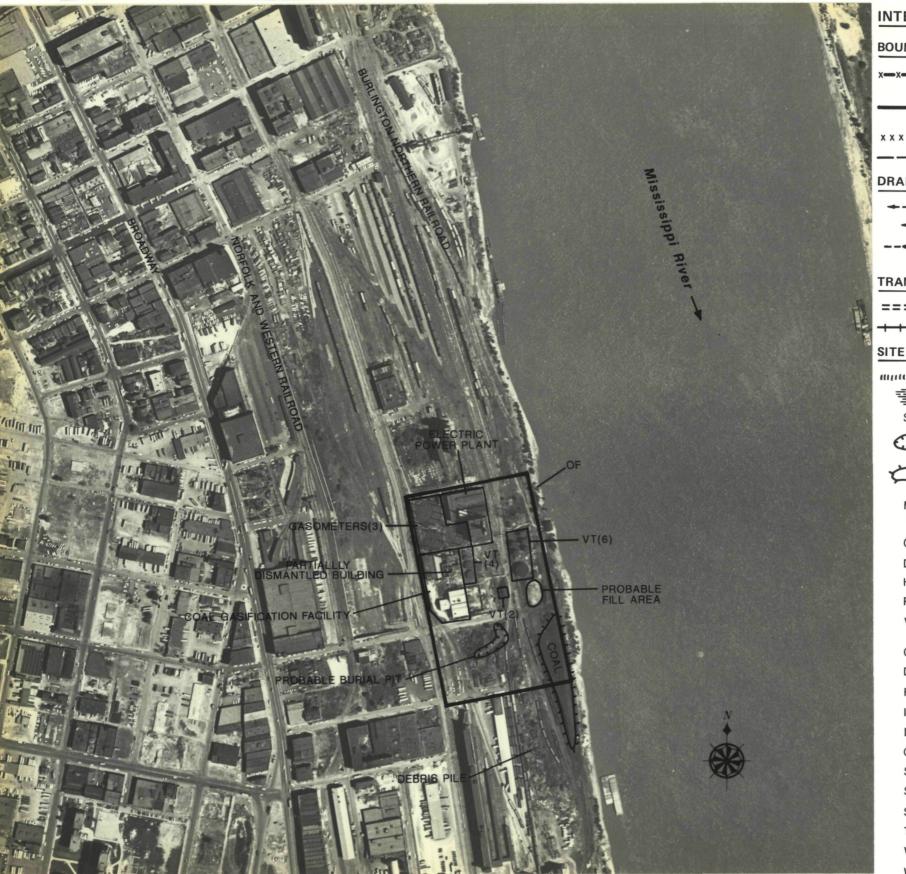
MAY 13, 1958 (FIGURE 5)

This years photography reveals the continued dismantling of the coal gasification facility. The roof in the north-central section of the facility has been removed exposing cubic cells of the infrastructure. The three gasometers appear to be deflated.

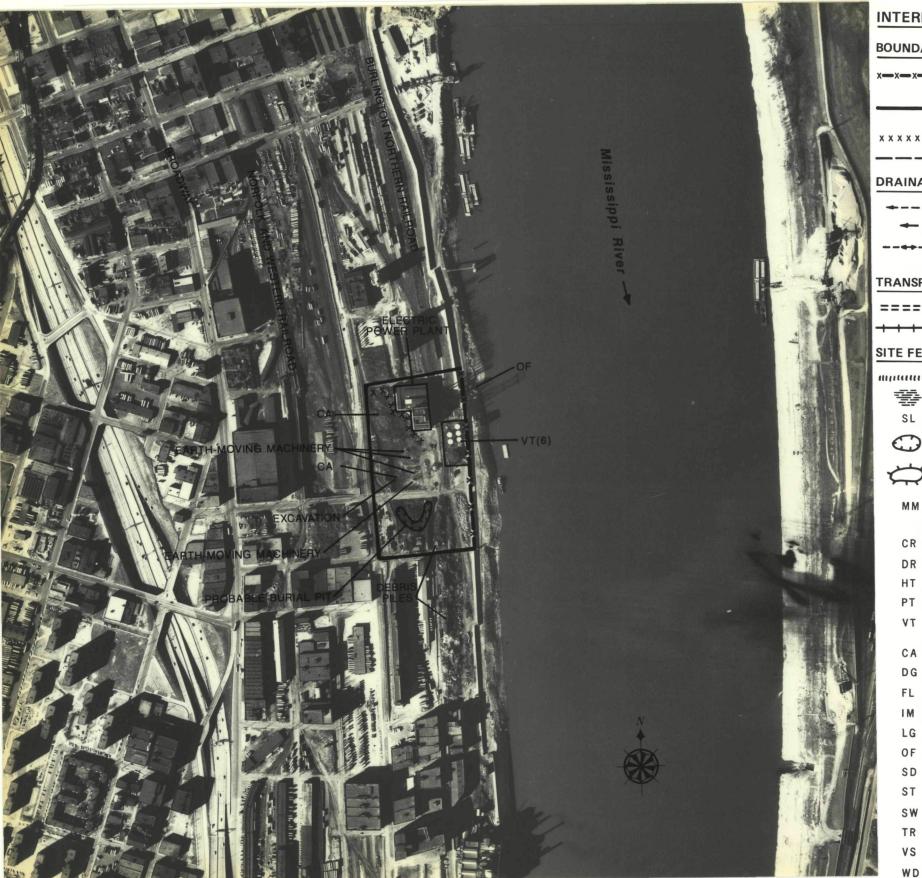
MARCH 3, 1968 (FIGURE 6)

The 1968 photography reveals significant changes occurred on the site. The coal gasification facility, three gasometers, and four vertical tanks have been removed. The area occupied by the facility has been cleared and earth moving activities appear to be ongoing. A fence has been constructed along the east side of the site. The fence runs parallel to the Mississippi River. The linear debris pile in the southern section of the site has considerably increased in volume.

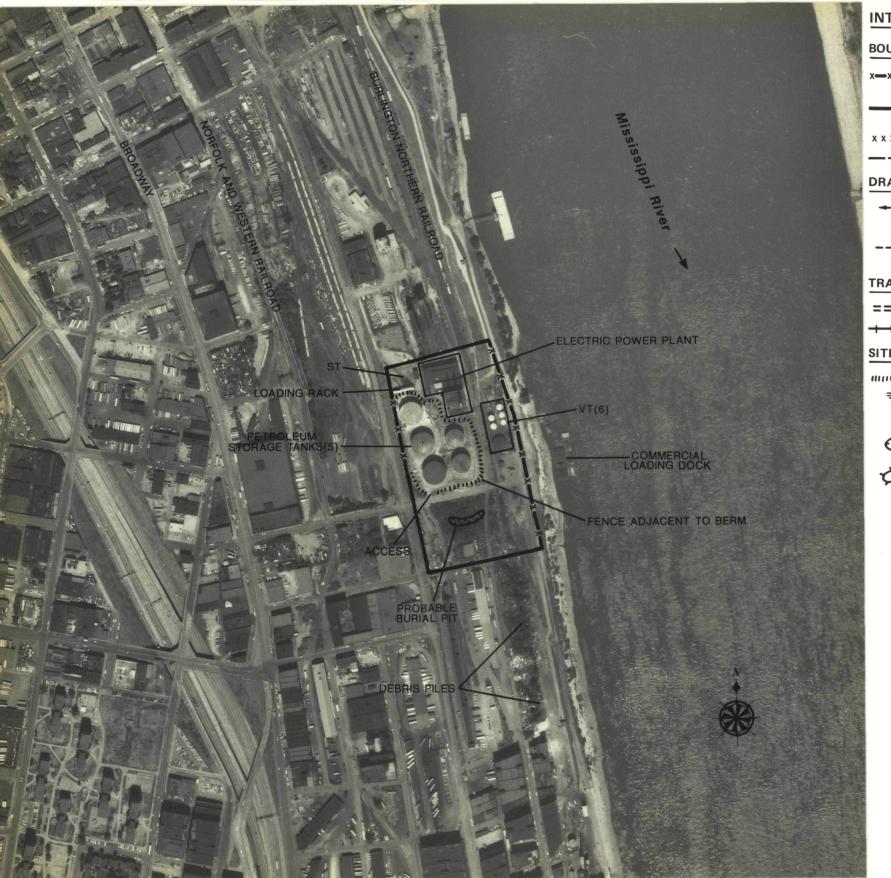
AUGUST 26, 1971 (FIGURE 7)

The 1971 photography shows the emplacement of five vertical petroleum storage tanks in the area previously occupied by the coal gasification facility. The petroleum tanks are contained by a berm and secured by a perimeter fence. A dark toned stain has been observed adjacent to the loading rack immediately north of the storage tanks.

The conduit discharging liquids into the Mississippi River is not evident on this years photography. The operational status of the electric power plant cannot be discerned.

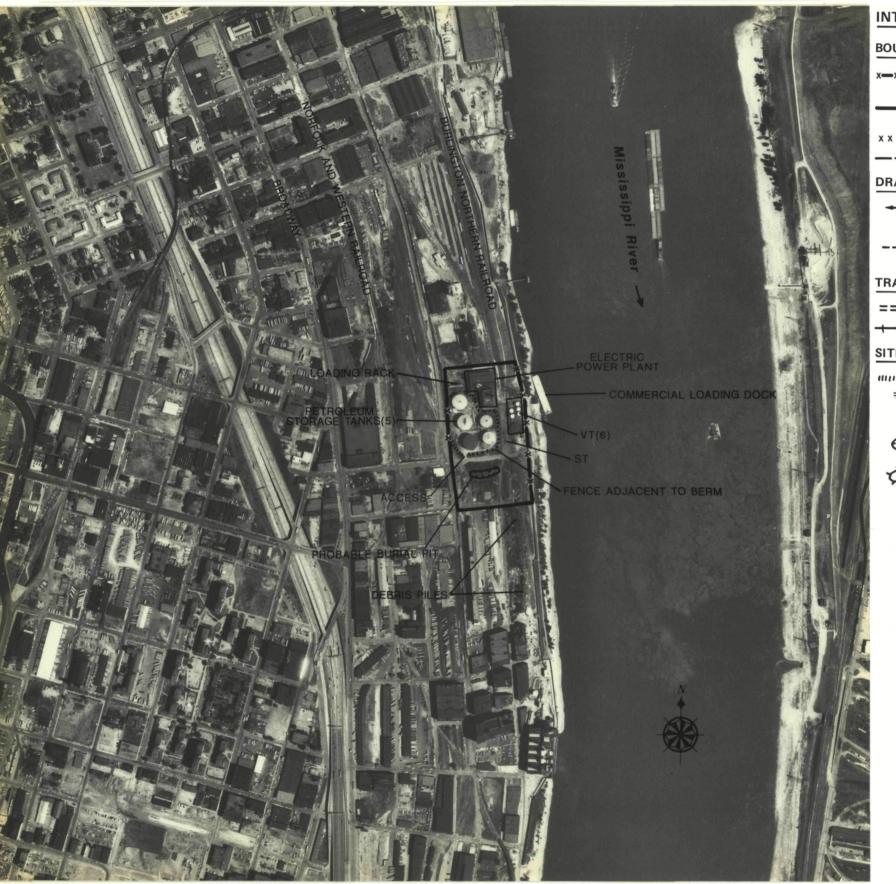
JULY 30, 1974 (FIGURE 8)

The 1974 photography reveals no significant alterations to the site.

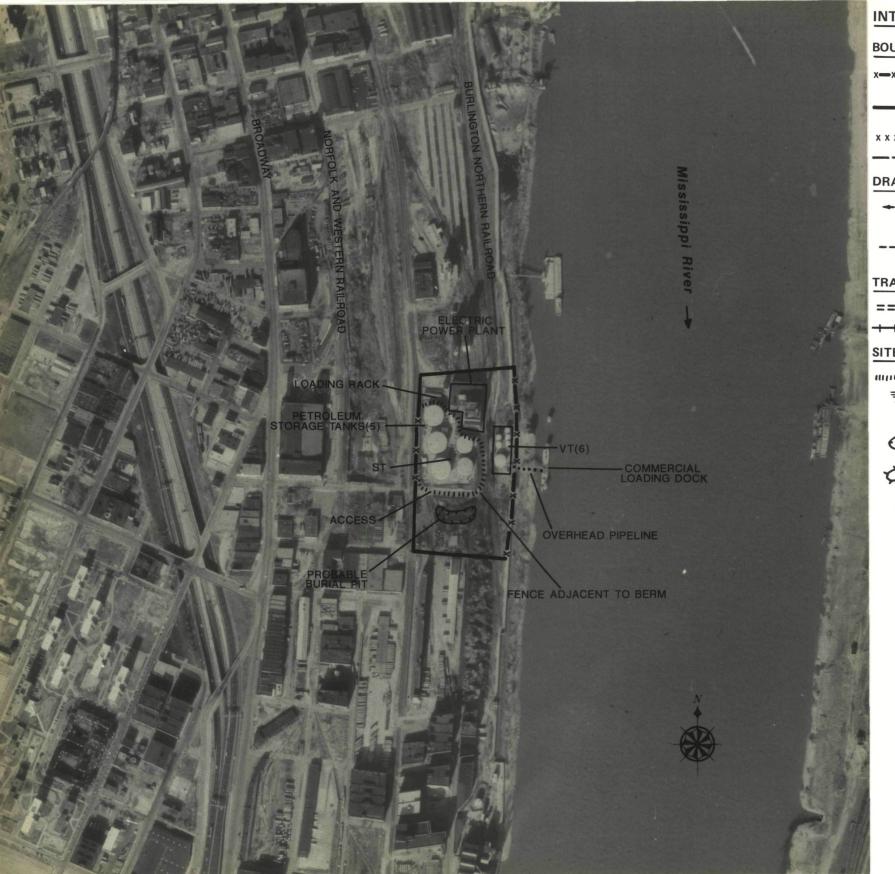
DECEMBER 14, 1980 (FIGURE 9)

The 1980 photography reveals the placement of a commercial loading dock on the Mississippi River directly east of the site. An overhead pipeline positioned on the loading dock, extends east, entering the eastside of the site. A dark-toned stain is identified underneath the piping which interconnects the petroleum storage tanks.

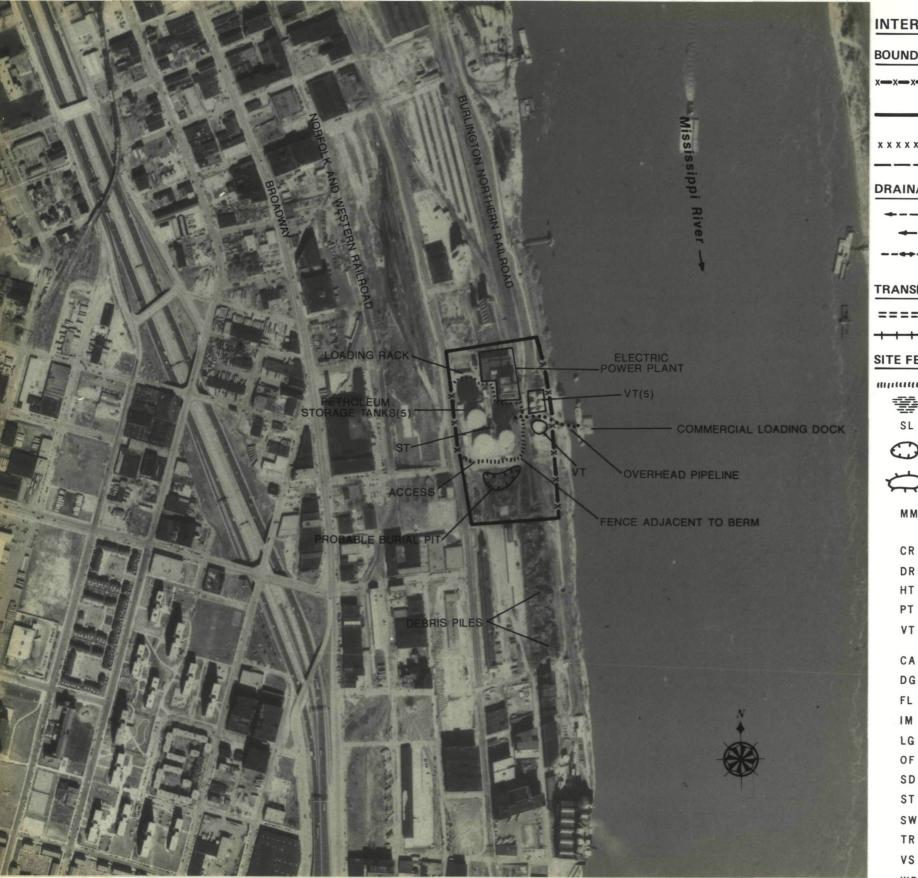
FEBRUARY 21, 1984 (FIGURE 10)

No significant changes have been observed on the 1984 photography

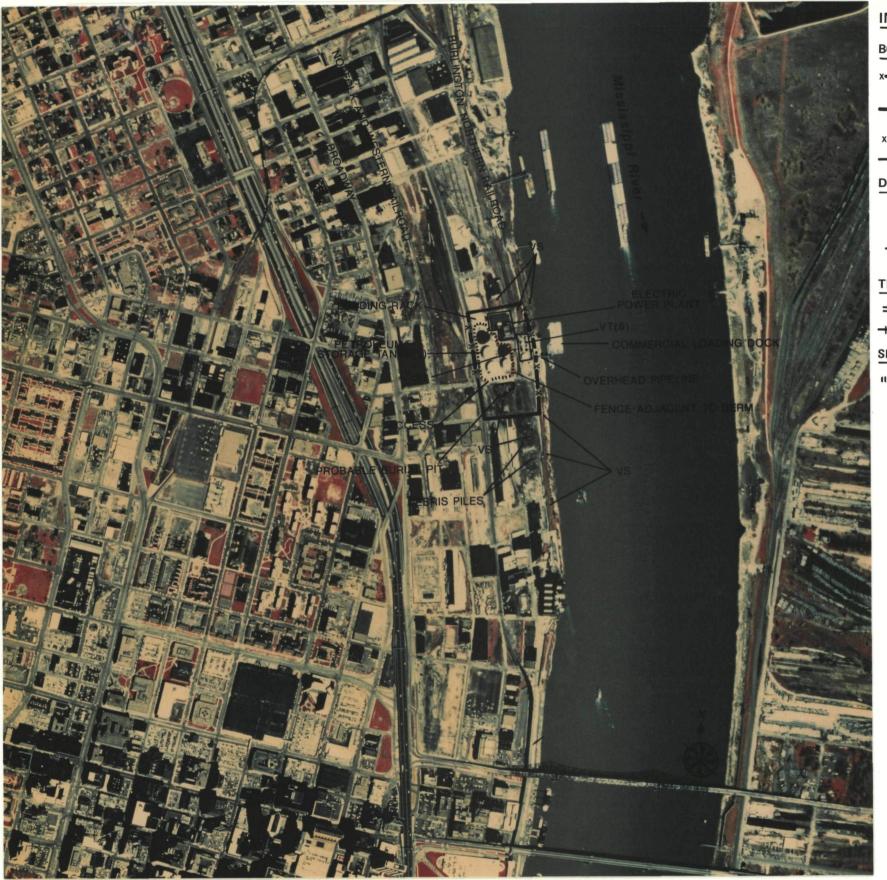
APRIL 7, 1988

The 1988 color infrared photography is an excellent source for the identification of vegetation stress. Areas of suspected vegetation stress have been observed along the banks of the Mississippi River, in the southern portion of the site, and areas to the immediate north and south of the site.
